TP 185E  
Issue 4/2013

# AVIATION SAFETY LETTER

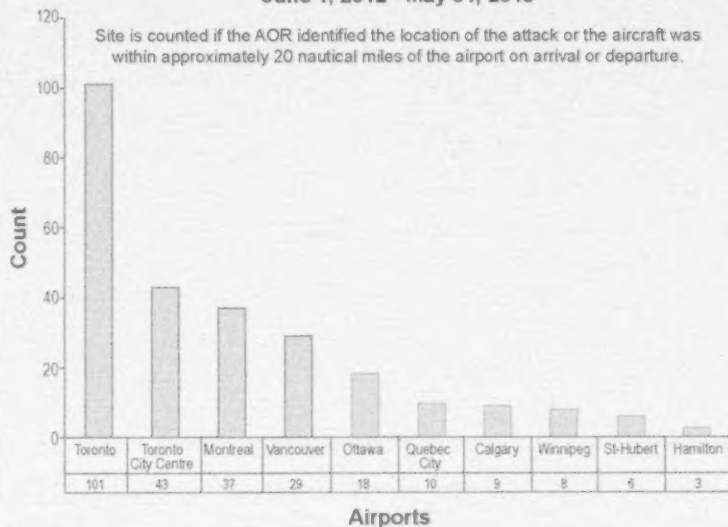
### Top Airports for Laser Attacks

June 1, 2012 - May 31, 2013

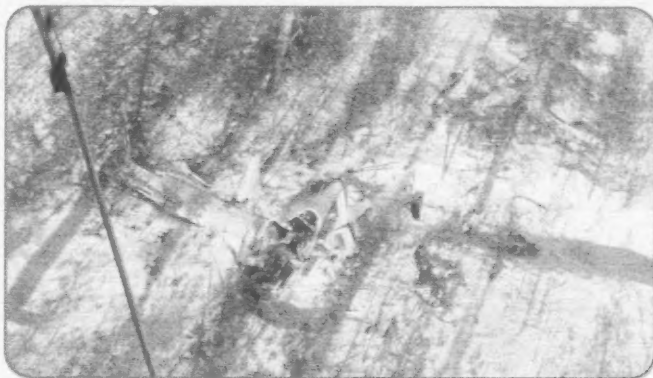
Wreckage debris and broken tree limbs were scattered about 300 ft along an approximate 200° magnetic heading from a broken tree. The airplane came to rest in approximately 6 ft of snow. The nose and the engine broke away from the fuselage and were buried in the snow. The cockpit of the airplane was exposed and the canopy broke away along the debris path. The right wing was attached to the fuselage but fragmented. The empennage broke away from the fuselage and was buried in snow along the debris path. The left wing broke away from the fuselage at the wing root and fragmented in the snow along the debris path.

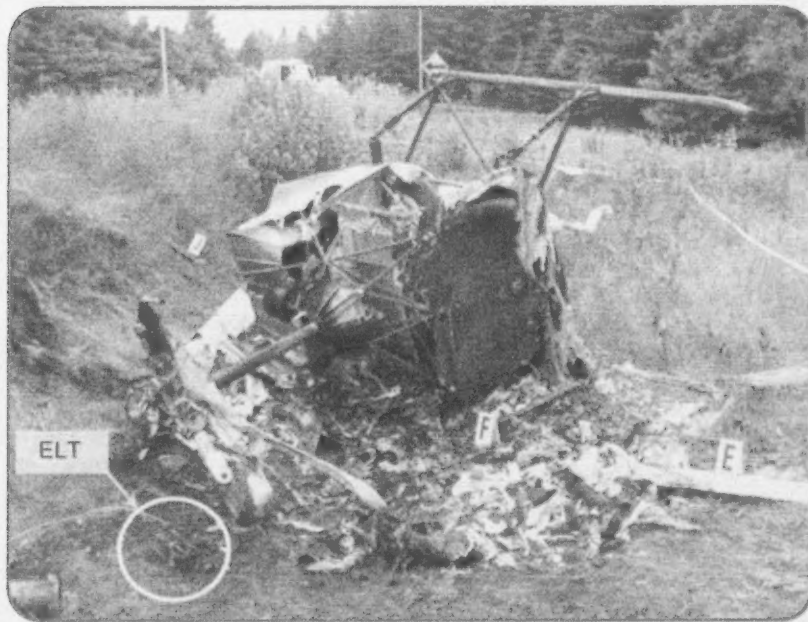
Wreckage of private Enstrom F-28C helicopter

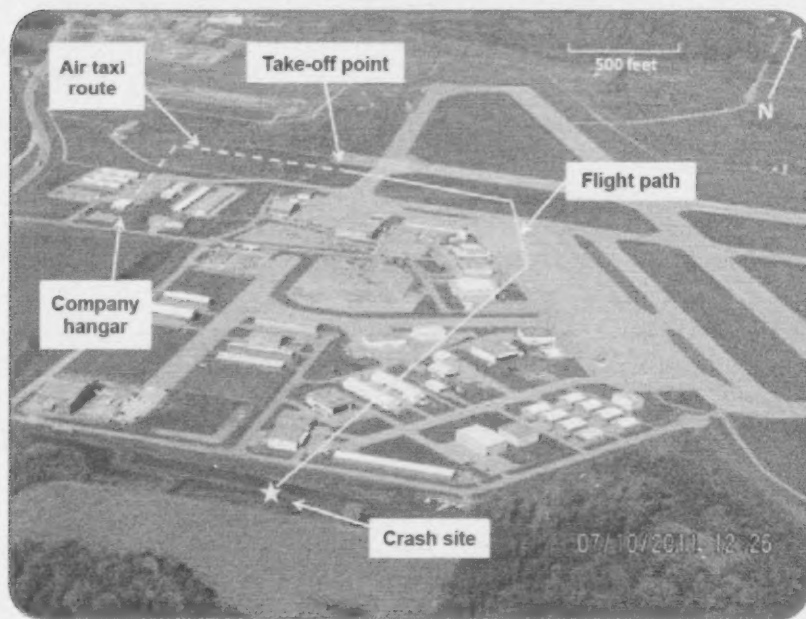
*Flight path*

The aircraft lifted off from the grassy area with the student pilot in control and proceeded as instructed by the air traffic controller. After reaching approximately 200 ft AGL, at a typical departure speed, southbound over an area of multiple hangars and overhead wires, the instructor instructed the student to apply carburetor heat. It is not clear whether this instruction was actioned; however, shortly thereafter, the engine shuddered, the engine rpm decreased, and the instructor assumed control. The helicopter yawed first to the left then back to the right and began to descend. At 11:31 EST, the R22 impacted the ground in a level pitch attitude with little forward velocity.

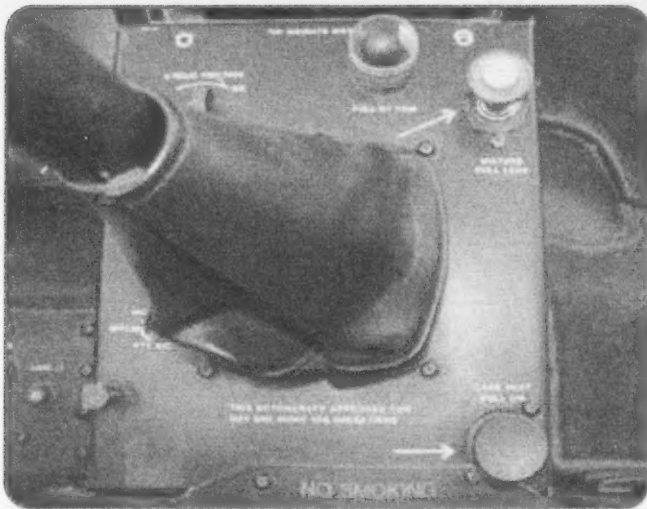
Photo 1: Mixture control top right and carburetor heat control bottom right

The fuel mixture and carburetor heat controls are located on the centre pedestal in close proximity to each other. To aid in identification, the control knobs are shaped differently. Furthermore, the fuel mixture control knob is red while the carburetor heat control knob is black (Photo 1). To prevent inadvertent deployment in flight, the manufacturer's checklist directs the pilot to place a removable cylindrical plastic guard over the mixture control knob before starting the engine (Photo 2). This guard is not to be removed until engine shutdown when the mixture control knob is pulled to the idle cut-off position (Photo 3). This plastic guard is not permanently attached to the control panel.

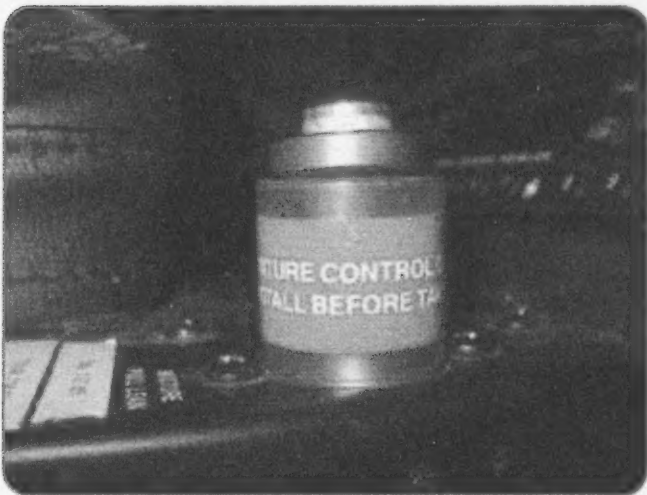
Photo 2: Mixture control with guard installed

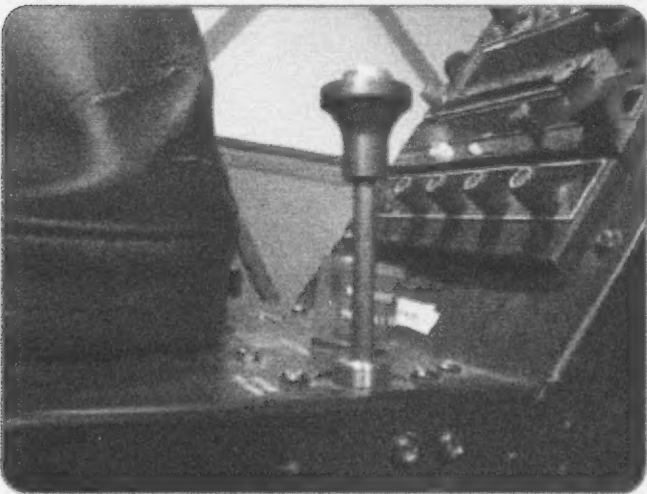
Photo 3: Mixture control in idle cut-off position

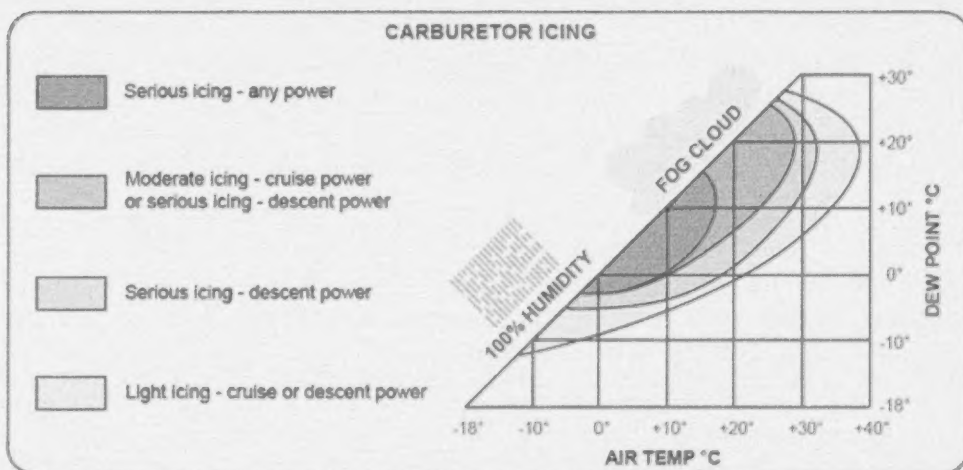
Carburetor icing probability chart

The weather conditions at CYKF were highly conducive to carburetor icing. In addition to the temperature/dew point spread, the operation conducted over wet grass would have intensified the rate of ice accumulation.

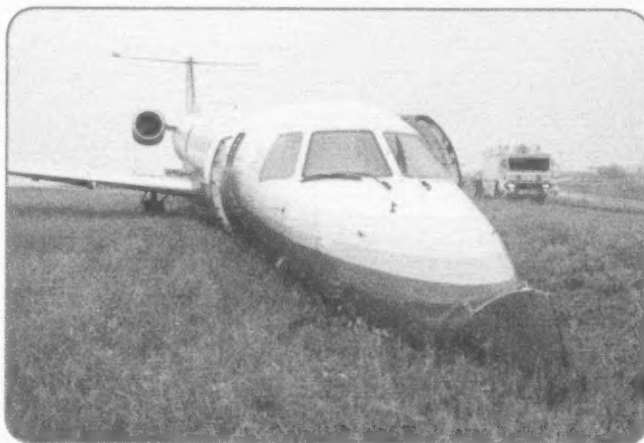
*The EMB-145LR following the occurrence*

8. The aircraft overran the runway threshold and the runway strip and subsequently encountered a significant dip, where the nose landing gear folded rearward, resulting in substantial damage to the nose of the aircraft.

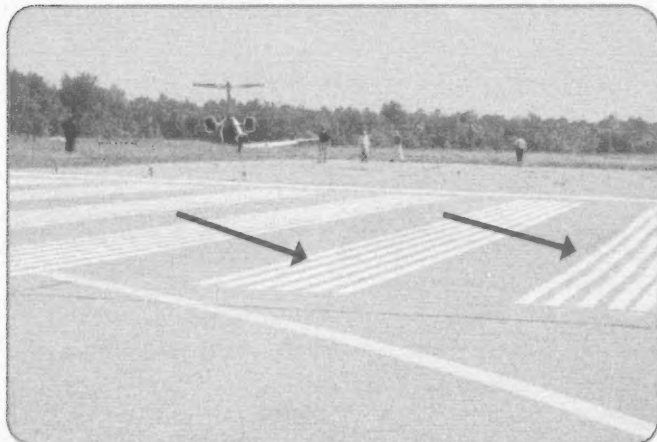
Steam cleaned marks observed on the departure end of Runway 07

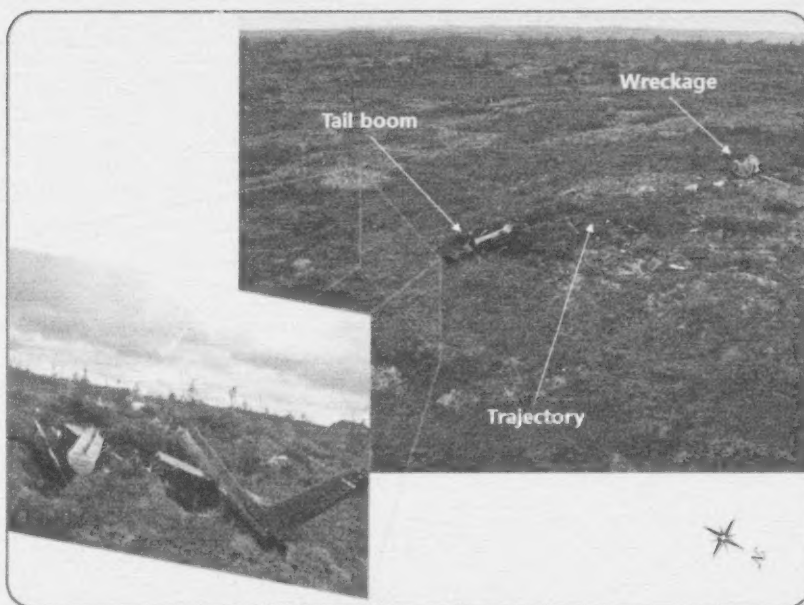
*Photographs of accident site showing helicopter wreckage and breakup trajectory*

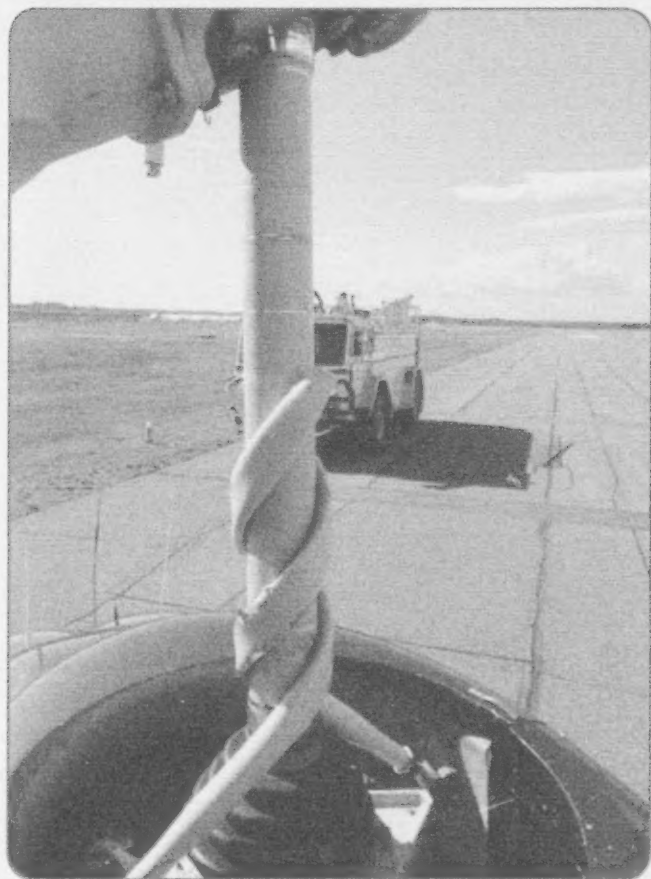
*Mast and pitch links*

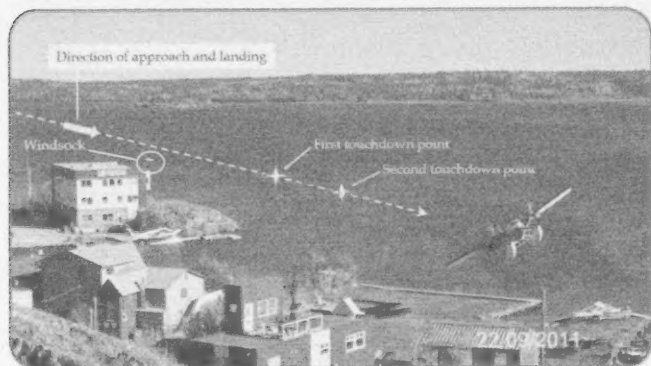
*DHC-6 over docks during overshoot*

Causing or allowing the nose to continue to pitch up when full power was added during the go-around meant that the airspeed could not increase. This resulted in the wings stalling and a loss of control.

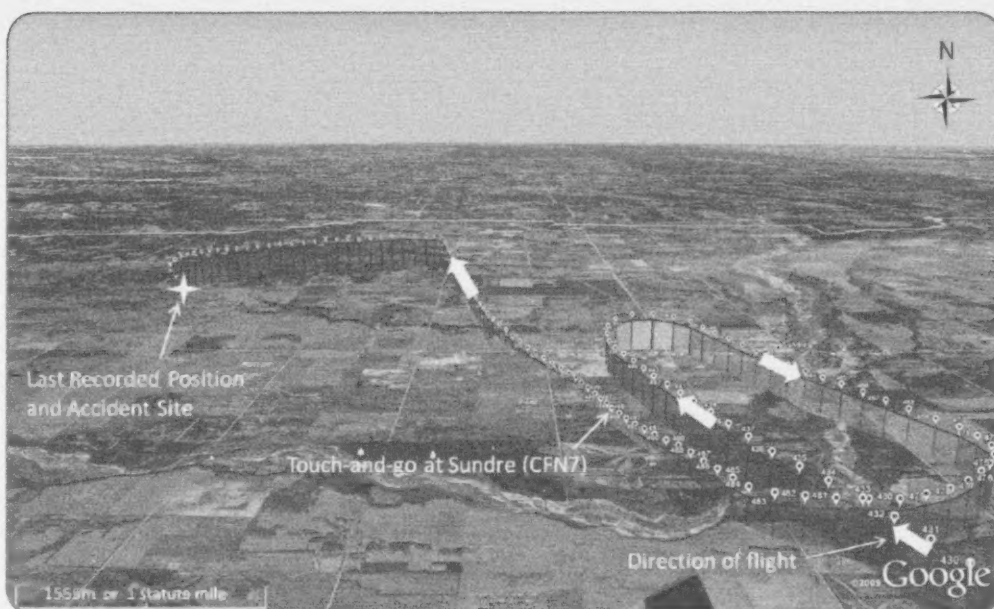
*Map of the last nine minutes of flight*

The airspeed deteriorated to the point of aerodynamic stall, which was followed by entry to a spin to the right with a heading change of 90°. The aircraft behaviour in the continued descent indicates an over-recovery into a spiral dive in the opposite direction which featured rapid rotation, speed build-up and increasing positive vertical g loading. Insufficient altitude remained for recovery. The debris field and ground scars indicate that most of the rotation was stopped and a pull-up had begun immediately before the aircraft struck the ground at high speed in a nose down, slight left wing down attitude.

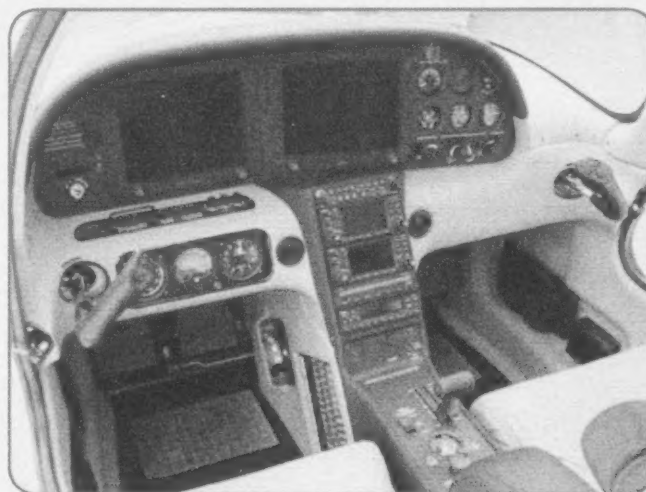
*Cockpit and flight controls of an SR22*

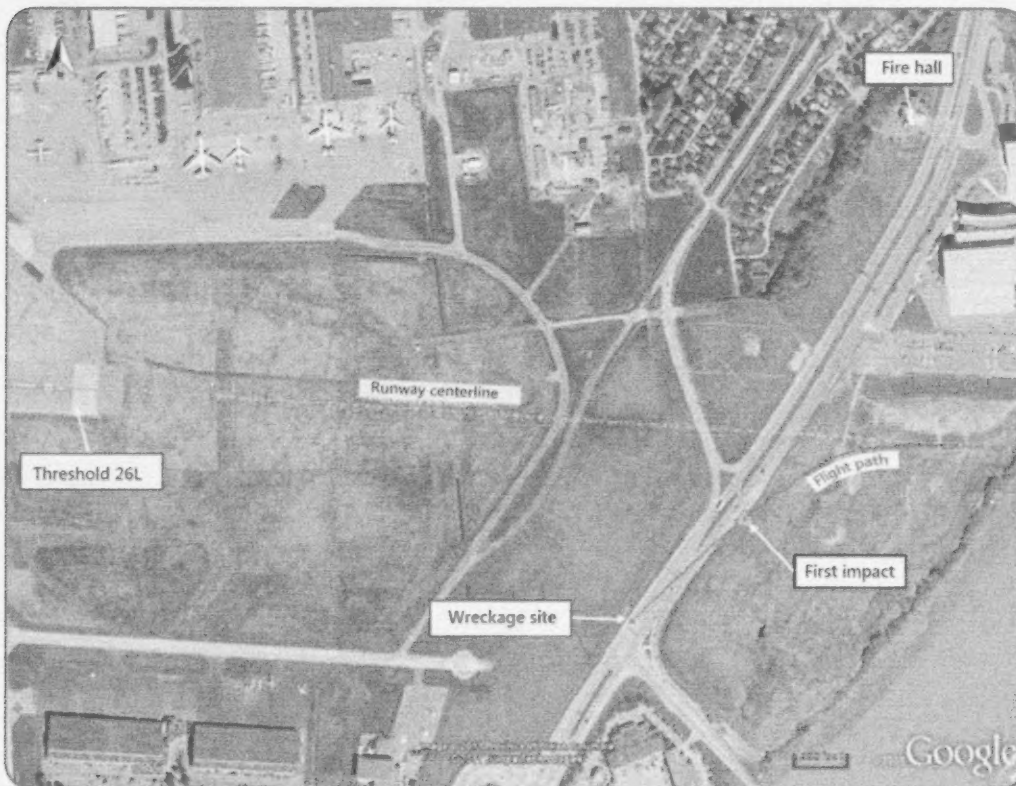
Enlarged diagram of final flight path

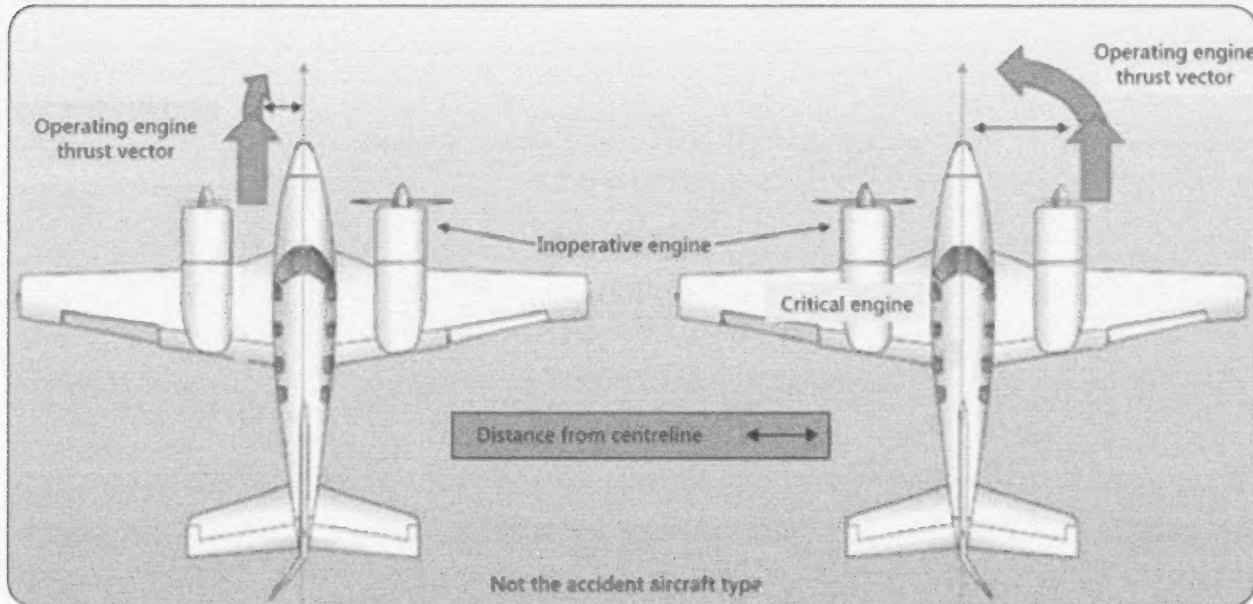
Source: *Airplane Flying Handbook*, FAA-H-8083-3A [US Government Printing Office, Washington DC: 2004], page 12–28. Modifications by TSB.

Information on the minimum speed at which directional control can be maintained with propellers not feathered and at normal rpm is not normally provided to flight crews. However, the propeller manufacturer calculated the drag produced by the aircraft's 4-blade propeller, turning at about 1 900 rpm, to be about 300 lbs.

The application of asymmetrical thrust at low airspeed with both engines operating can result in a loss of directional control.

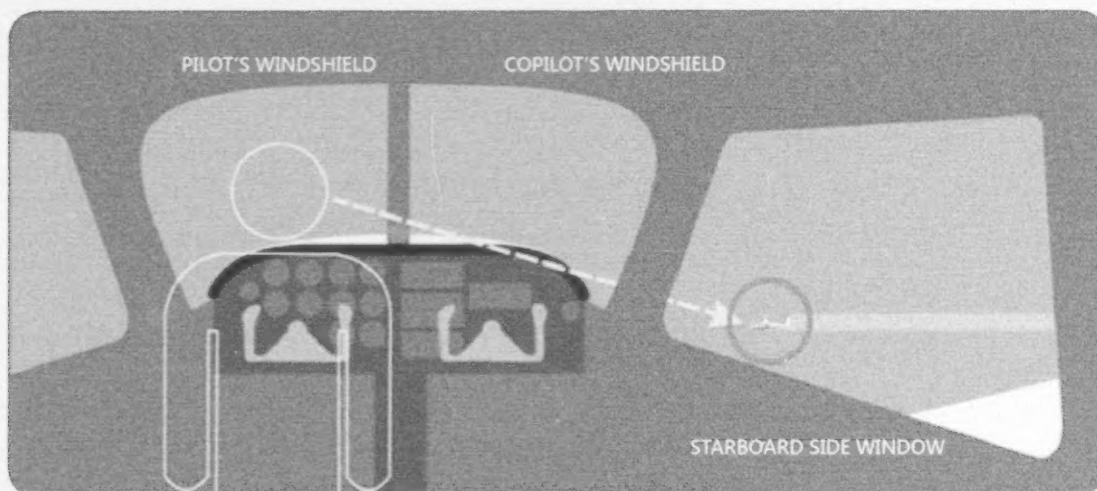
*View from cockpit of the PA-28 indicating pilot's view partly obstructed by nose of aircraft  
(Note: Image not to scale.)*

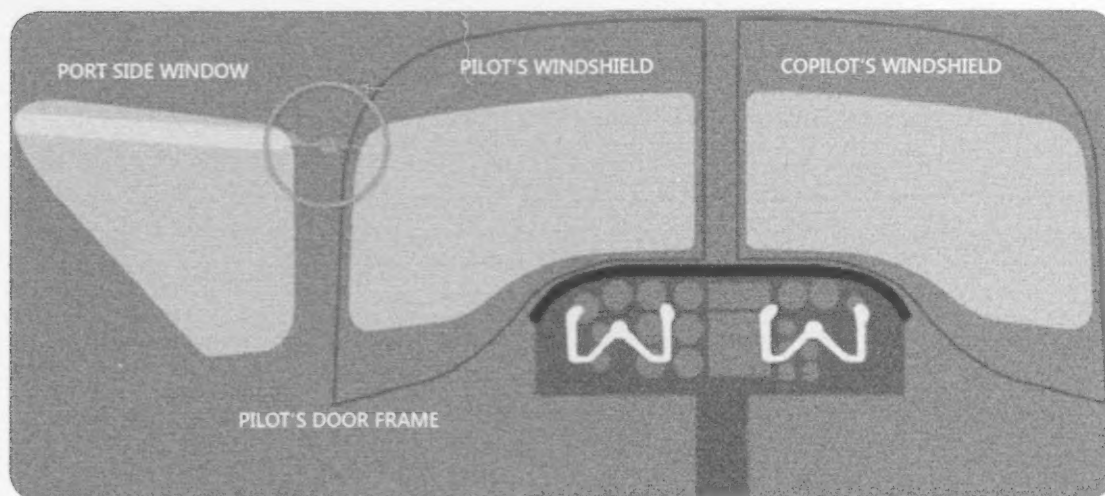
*View from cockpit of the LA-4 indicating pilot's view partly obstructed by aircraft structure  
(Note: Image not to scale.)*

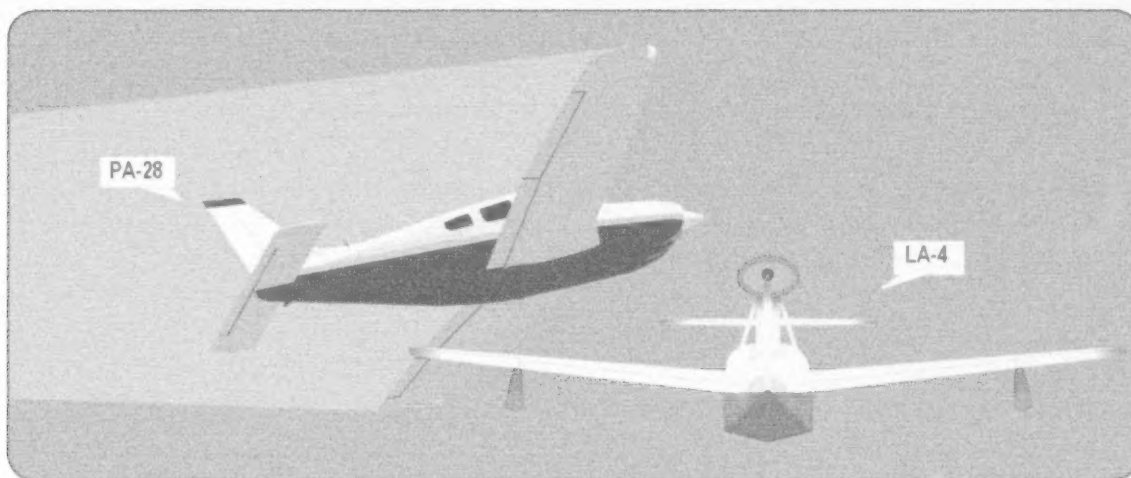
*Relative positions of the aircraft at impact*

Inspection of the damage to both aircraft left wings and ailerons indicated that the pilot of the PA-28 might have banked to the left, turning northward and away from the LA-4. This type of evasive action would have resulted in the PA-28's left wing being down to the point where it could only have come in contact with the left wing of the LA-4. A reconstruction of the likely aircraft positions at impact was prepared (see image above). The left outboard wing sections came to earth very close to each other and away from both main wreckage sites.

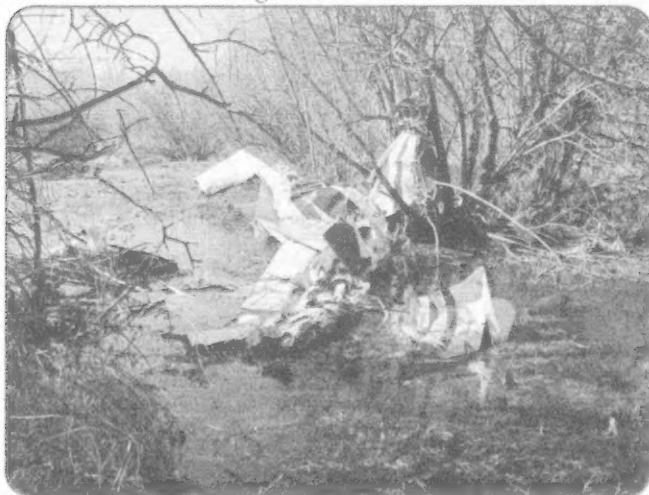
*Wreckage of the Lake LA-4 200 in a marsh*
